Manhole Inspection Summary

Manhole # S39KK_038MH

Insp Date: **1/22/08 9:22 AM**

Location Address: **1733 ENSOR ST**

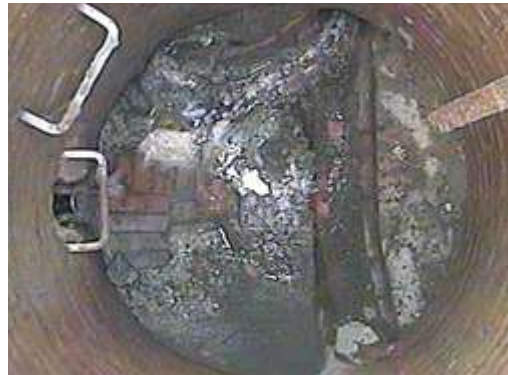
Top View

LOTS OF SLUDGE AND DEBRIS ON BENCH AND IN CHANNEL.

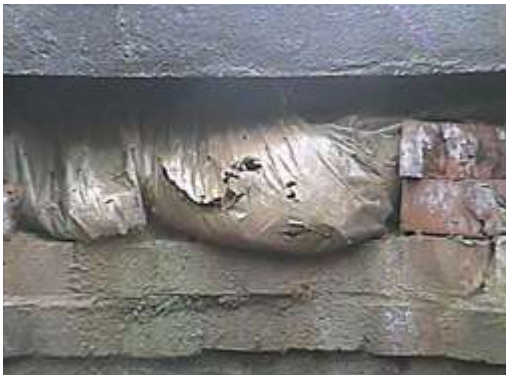
Defect 1

Condition: ☐ Sound ☐ Cracked ☐ Root Intrusion ☐ Loose Brick ☒ **Deteriorated**

CRAPPY FRAME ADJUSTMENT

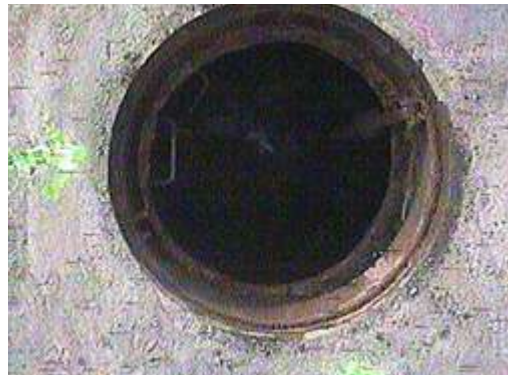
Defect 2

Offset: **2** (in.)

frame offset

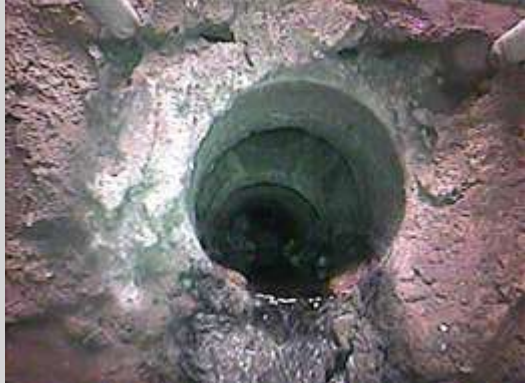
9 O'Clock Inflow

Deposits: ☐ None ☐ Mud ☒ **Sludge** ☒ **Debris** ☐ Grease

Silt Depth: **0.5** (in.) Deposits Extent: **Light**
